Inspection Report

Property Address:
123 KDF Way
Montgomery tx 77356

KDF Home Inspections

PROPERTY INSPECTION REPORT

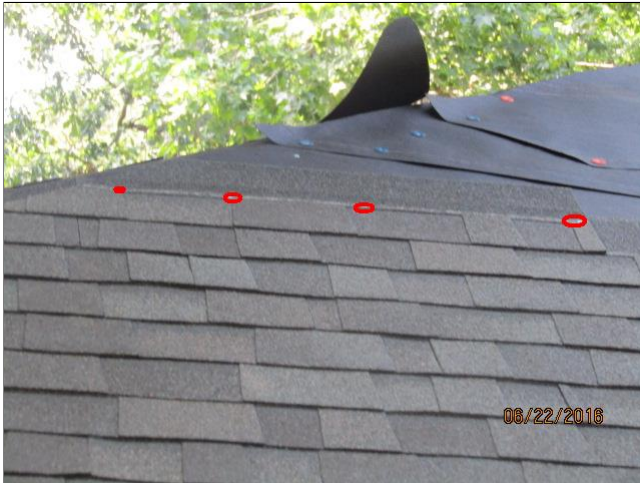
(1) The roof covering was not completely installed at the time of inspection.

C. Item 1(Picture) Suficent fastener pattern in composite shingle roof at time of inspection.

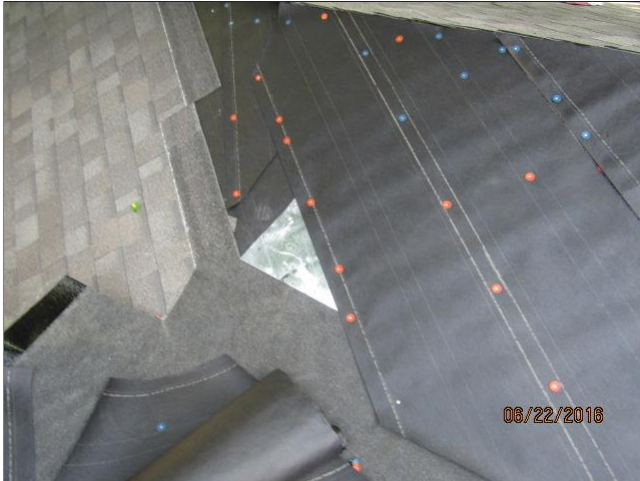
(2) Sufficient use of Valley Flashing on Newly installed roof.

C. Item 2(Picture) Sufficient use of Valley metal flashing.

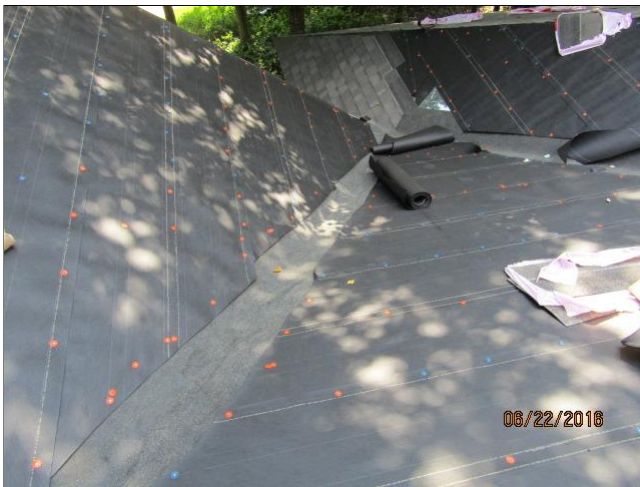
(3) Valley Flashing installation.

C. Item 3(Picture) Sufficient valley flashing.

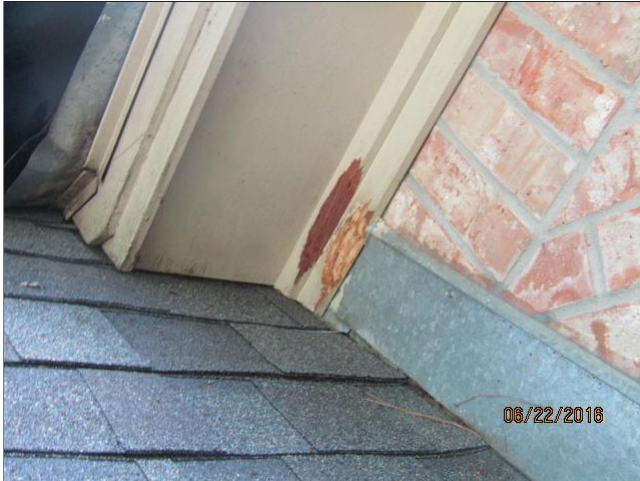
Damage to Freeze board on front of house, Suggest repairs be made to avoid deterioration of exposed wood.

E. Item 1(Picture) Damage at Front Gable roof Freeze Board

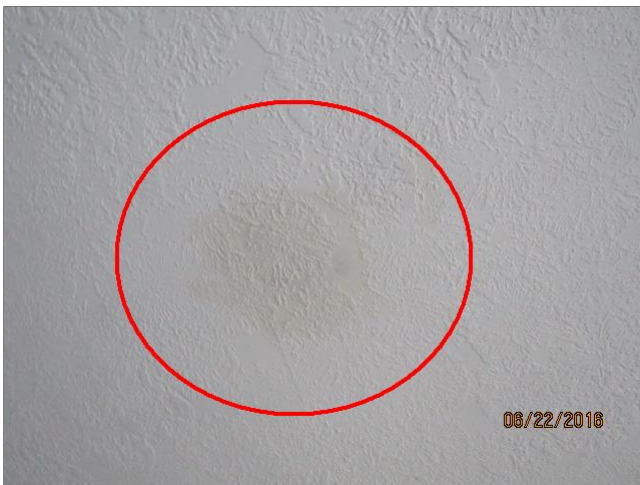
(1) The Sheetrock on the ceiling reveals a light stain at Garage which appears from a water leak. Stain appears old and has multiple cracks also shows repair signs at the garage. While this damage is cosmetic, This is a small repair issue for your information.

F. Item 1(Picture) Ceiling Drywall stain In Garage.

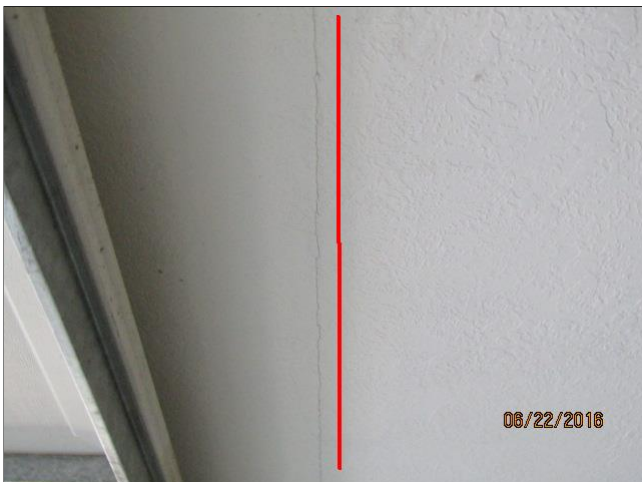
(2) The Drywall on the ceiling reveals a water stain indicating a leak did or still exists at the Attached garage. While this damage is cosmetic, the repair cost should be considered due to the amount of damage. A qualified person should repair or replace as needed.

F. Item 2(Picture) Drywall crack in garage indicated the left of red line in photo

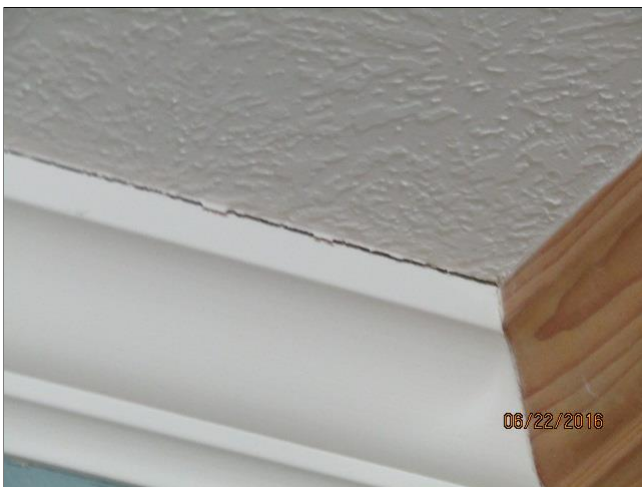
(3) Failing cosmetic sealant in Office.

F. Item 3(Picture) Cosmetic failing sealant at ceiling in office.

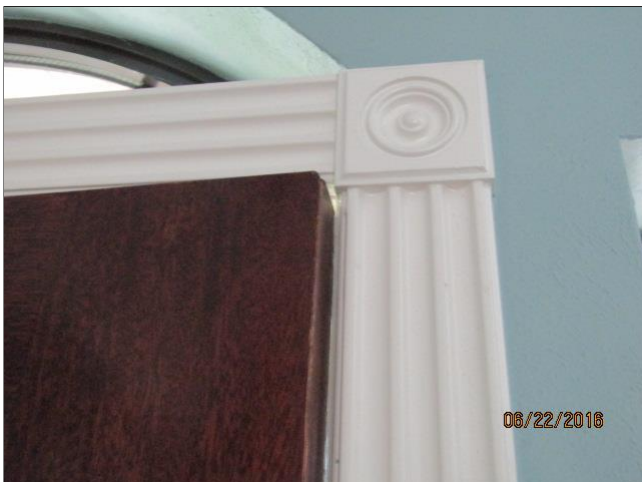
(1) The Entry door needs adjustment at the Living Room. This is a small repair I recommend repair as desired.

G. Item 1(Picture) Entry Door sticking at door frame

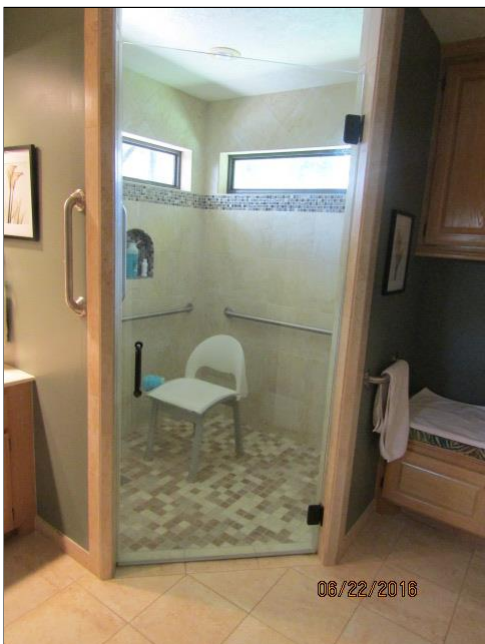
- (2) The sensors are in place for garage door(s) and will reverse the door.
- (3) The garage door will reverse when met with resistance.
- (4) Glass pane in Master bathroom shower entry door does not have visible labeling as safety glass.

G. Item 2(Picture) Master bath Shower Door.

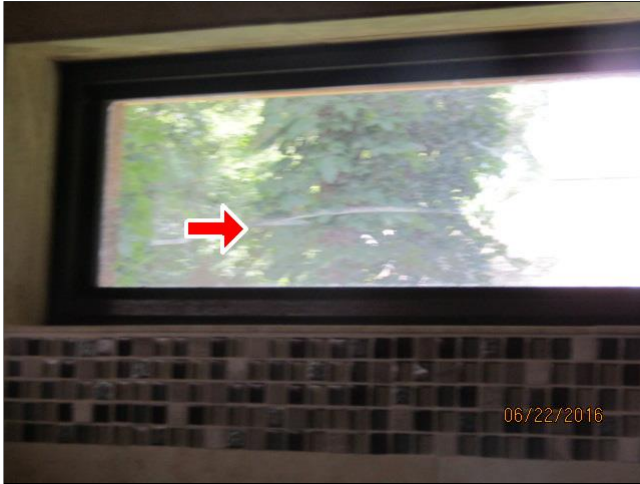
- (1) One window cracked at glass pane at the Master bath. A repair may be needed. .

H. Item 1(Picture) Crack in Glazing.

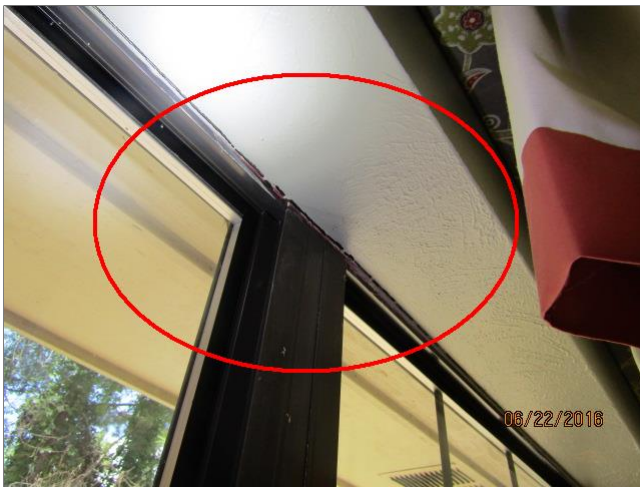
(2) Multiple window have failing Sealant, Sealant throughout a house is a regular maintenance issue that should be monitored regularly and replaced when necessary. This is a small repair.

H. Item 2(Picture) Failing sealant at window head in den.

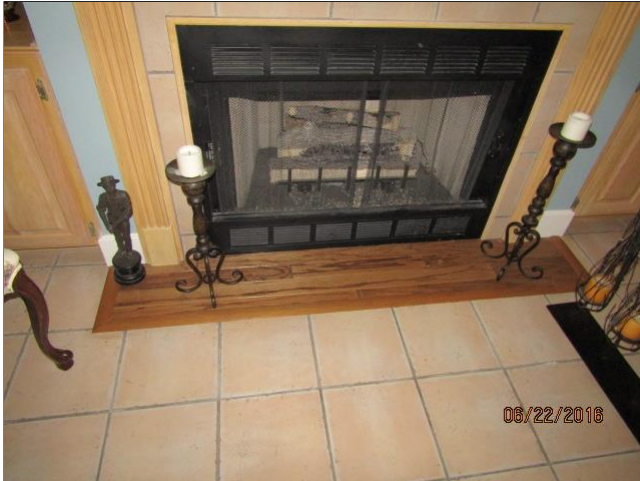
Wood Flooring for stand alone Fireplace at the Living room Is not approved for use as any fireplace hearth extension. . I recommend repair or replace as needed.

J. Item 1(Picture) Combustibles should not be used as
Hearth Extension.

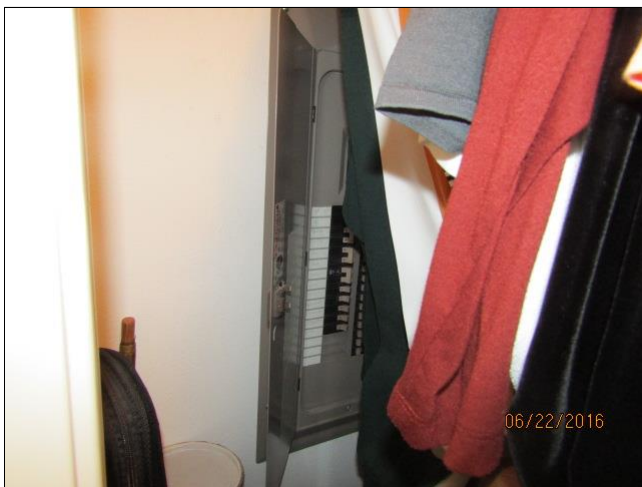
Electrical service panel was not accessible.

A. Item 1(Picture) Service Panel in Closet at northeast bedroom.

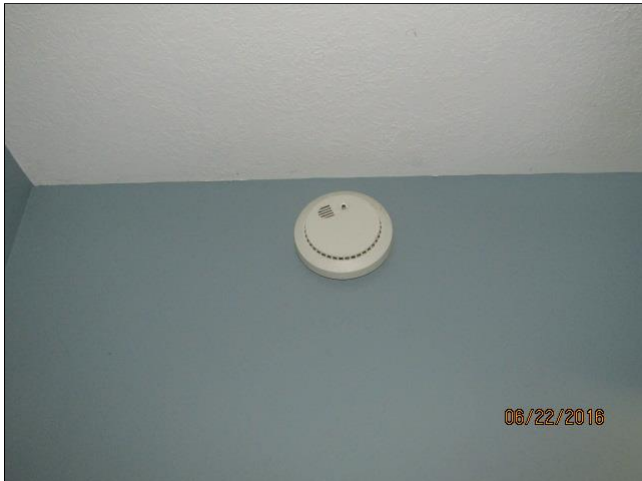
(3) The smoke detector has been disconnected intentionally and did not work when tested at the common hallway to bedrooms. Without a working smoke detector in your home you have no first alert to a possible fire.

B. Item 1(Picture) Inoperative Smoke detectors throughout home.

(4) The smoke detector is needed at the bedrooms throughout structure and all smoke alarms should be interconnected when installed.

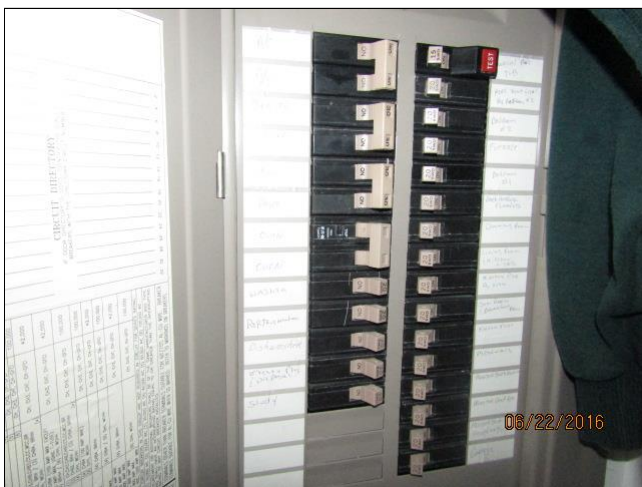
(5) Fuses to Branch Circuits labeled in service panel box.

B. Item 2(Picture) Branch Circuits Labeled.

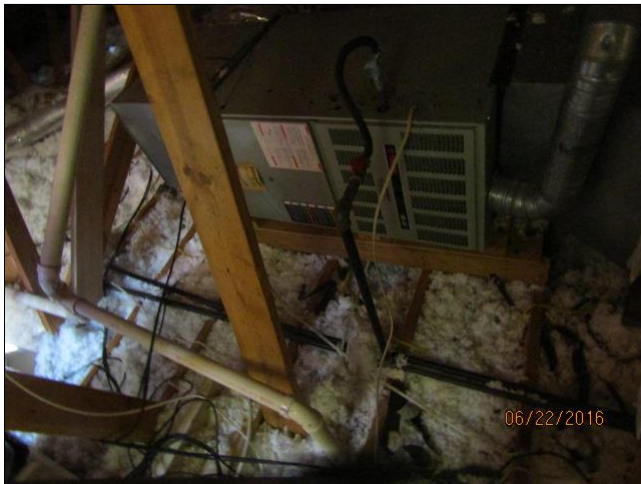
(1) Our company did not inspect the gas furnace. Temperature above 75 degrees, operating heating equipment when exterior temperature is high risks damaging heating equipment and Due to Lack of safe working platform . A qualified licensed HVAC (Heat/Ventilation/Air conditioning Contractor) should inspect further..

(2) Absence of Secure work platform at attic furnace.

A. Item 1(Picture) Missing Secure work platform at front of Furnace about Garage.

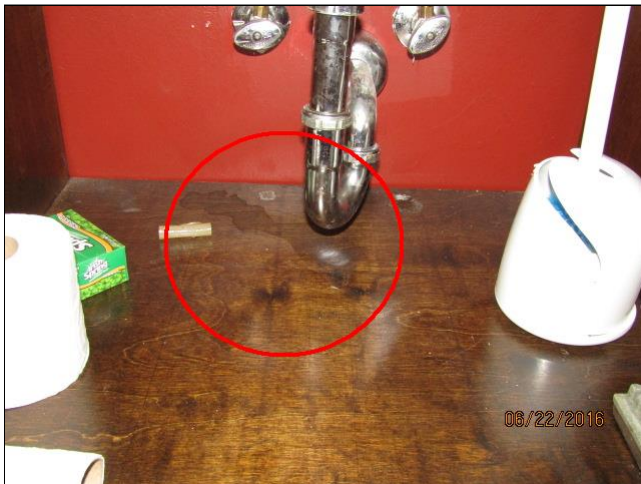
(1) The plumbing waste line has evidence of previous leak. at the Half Bath sink. Upon testing, there was no active leak at the time of inspection. . Monitor area regularly. .

B. Item 1(Picture) Water stain in Half Bath.

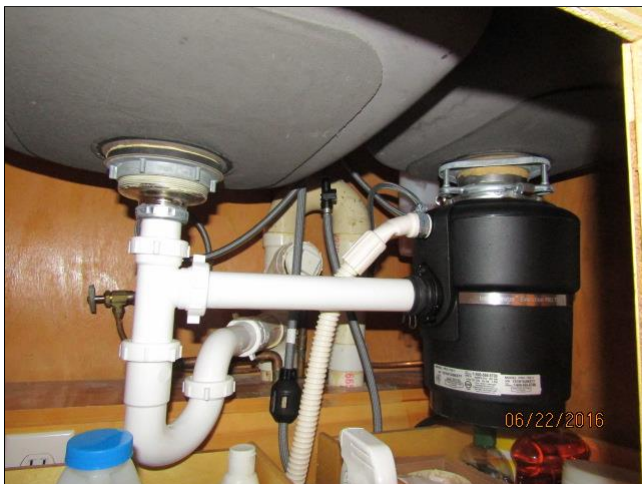
(3) Garbage Disposal drain line have anti siphon loop to prevent drainage from Disposal into dishwasher.

B. Item 2(Picture) Kitchen Sink Drain lines.

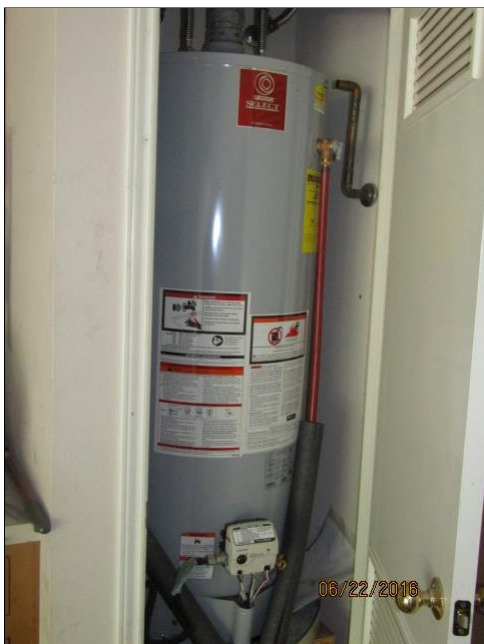
(1) The flame/burner for water heater appeared to burn evenly and cleanly at the time of inspection.

C. Item 1(Picture) Water Heater in Closet at back of garage.

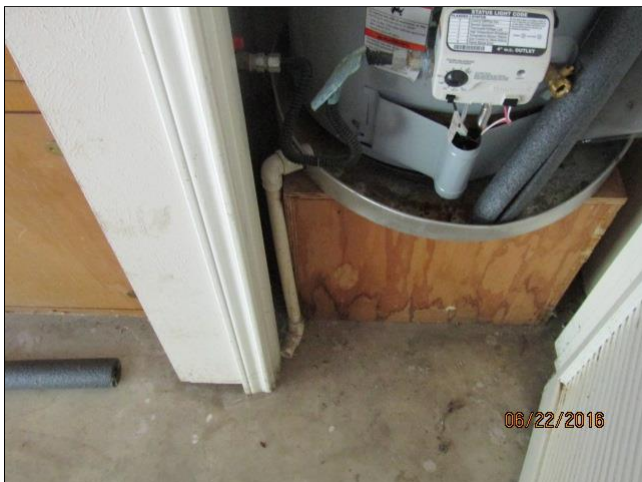
(2) The water heater drain pan drain line does not carry water to outside of building. This modification was likely made when new water heater was installed. Recommend correction be made.

C. Item 2(Picture) Water Heater Drain Pan/ Line

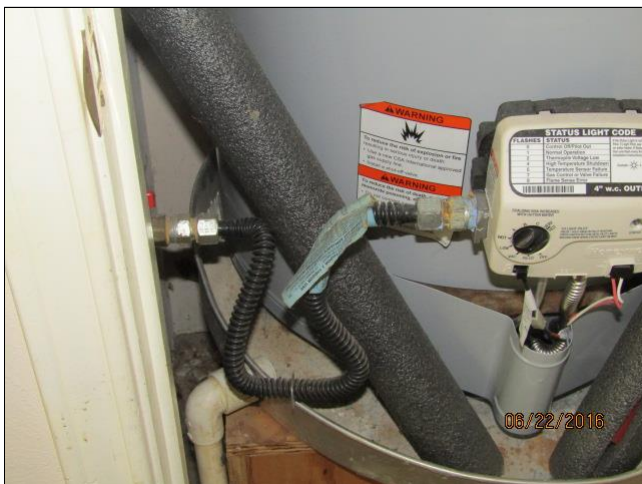
(3) Galvanized gas line and Water heater not electrically bonded together, meaning there is no direct mounted electrical conductor contacting gas line and water heater. This conductor ensures that an electrical surge flowing from the water heater will have a safe path to travel another metal conductor.

C. Item 3(Picture) Flexible gas Connection Line at Water Heater.
